DEPARTMENT OF TRANSPORTATION

Quality Assurance and Source Inspection

Contract #: 04-0120F4Cty: SF/ALA Rte: 80 PM: 13.2/13.9File #: 69.28**WELDING INSPECTION REPORT****Resident Engineer:**Siegenthaler, Peter**Address:** 333 Burma Road**City:** Oakland, CA 94607**Report No:** WIR-021323**Date Inspected:** 03-Mar-2011**Project Name:** SAS Superstructure**OSM Arrival Time:** 700**Prime Contractor:** American Bridge/Fluor Enterprises, a JV**OSM Departure Time:** 1900**Contractor:** Zhenhua Port Machinery Company, Ltd (ZPMC), Changxing Island **Location:** Shanghai, China**CWI Name:** Zho Zhong Hai**CWI Present:** Yes No**Inspected CWI report:** Yes No N/A**Rod Oven in Use:** Yes No N/A**Electrode to specification:** Yes No N/A**Weld Procedures Followed:** Yes No N/A**Qualified Welders:** Yes No N/A**Verified Joint Fit-up:** Yes No N/A**Approved Drawings:** Yes No N/A**Approved WPS:** Yes No N/A**Delayed / Cancelled:** Yes No N/A**Bridge No:** 34-0006**Component:** Orthotropic Box Girder(OBG)**Summary of Items Observed:**

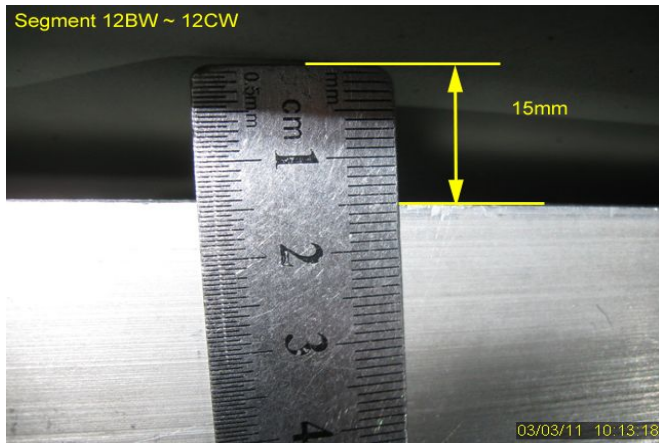
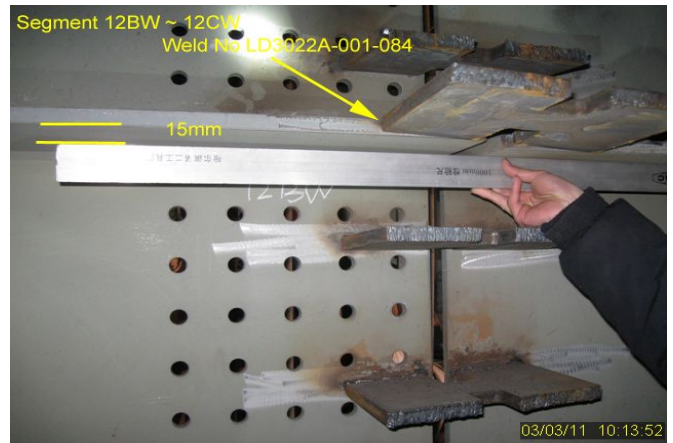
- The Offset caused by welding measured approximately 15mm on the Side plate of 12BW.
- The Weld is identified as LD3022A-001-084, 085
- The LD Plate is identified as: LD3022A
- The distortion was measured using a 1000 straight edge.
- LD3022A is located on the Cross Beam Side of the segment
- This QA inspector observed ZPMC performing the cutting operation of weld joint LD3022A-001-084. This QA inspector reviewed the Welding Repair Report (WRR) B-WR 19623 prior to cutting apart weld joint LD3022A-001-084 to correct the distortion on the Stiffener. See attached photo for further details.
